NATIONAL REGISTER OF HISTORIC PLACES

Rose Hill

Louisburg vicinity, Franklin County, FK0431, Listed 5/3/2006 Nomination by M. Ruth Little Photographs by M. Ruth Little, August 2005 and January 2009

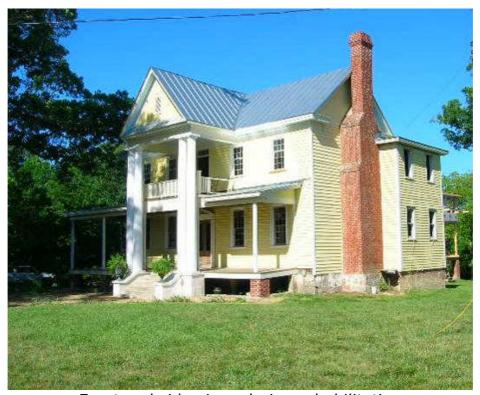
Front and side view, during rehabilitation

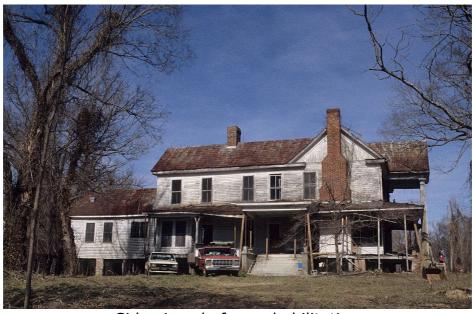
Side view, before rehabilitation
